## Walsh Home Inspections, LLC

## Visual Inspection Report

**123**

**Anywhere Lane**

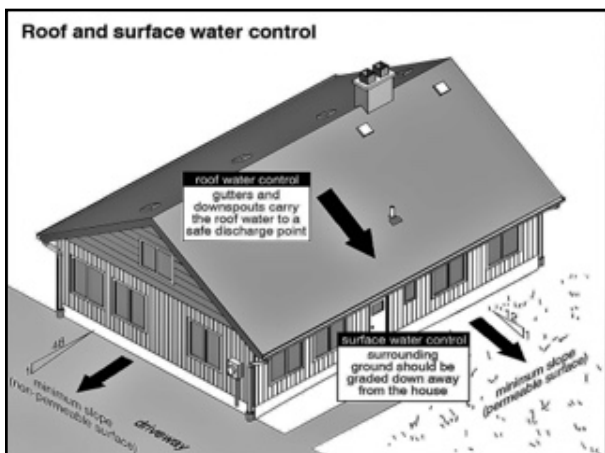
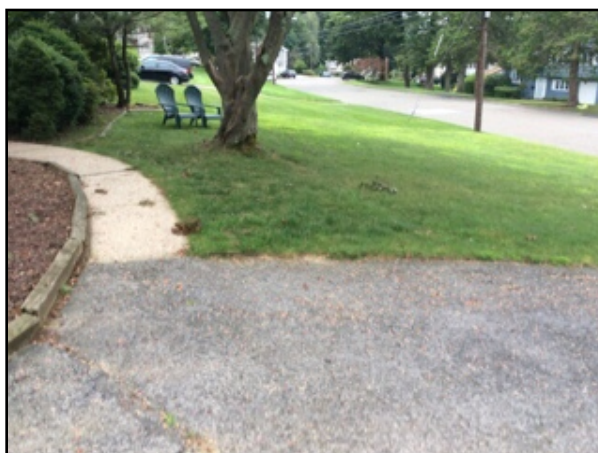
Figure 1-1

As practical, at least 6 feet of pitch must be maintained, with a minimum of 1 inch per foot for all soil grading away from the foundation. This will assist in proper drainage of the roof which will also help minimize pressure on the foundation walls. Site conditions continually change, monitor from time to time.

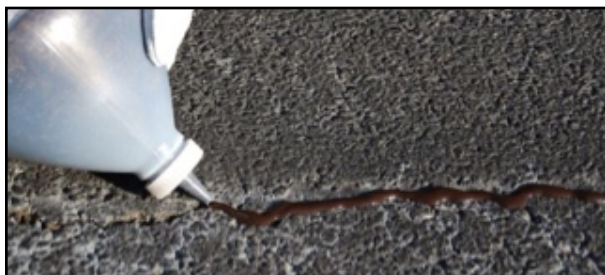
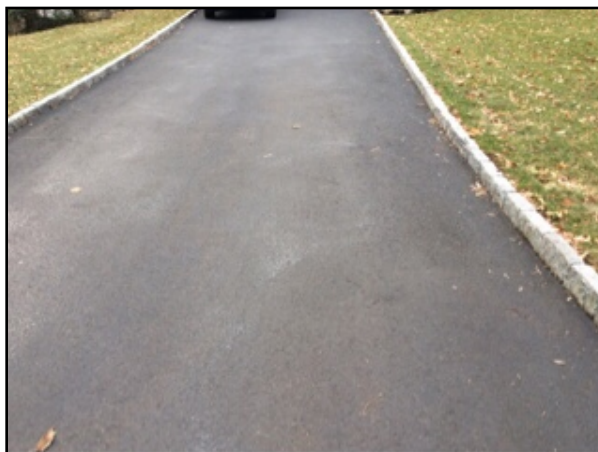
Figure 2-1

Driveway OK at the time of the inspection. As the asphalt begins to show signs of wear, fill any cracks with rubberized crack filler and seal the surface every 2-3 years to extend service life.

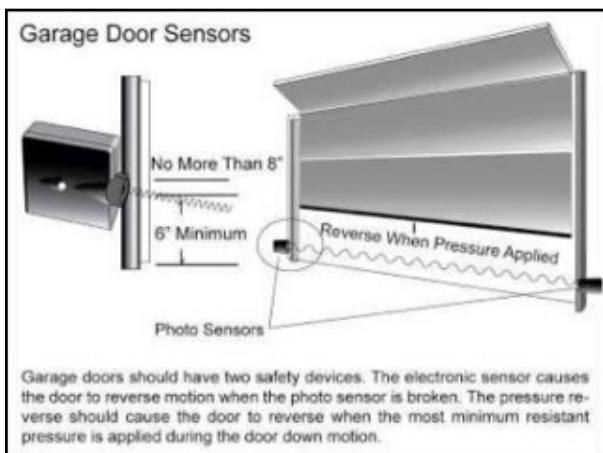
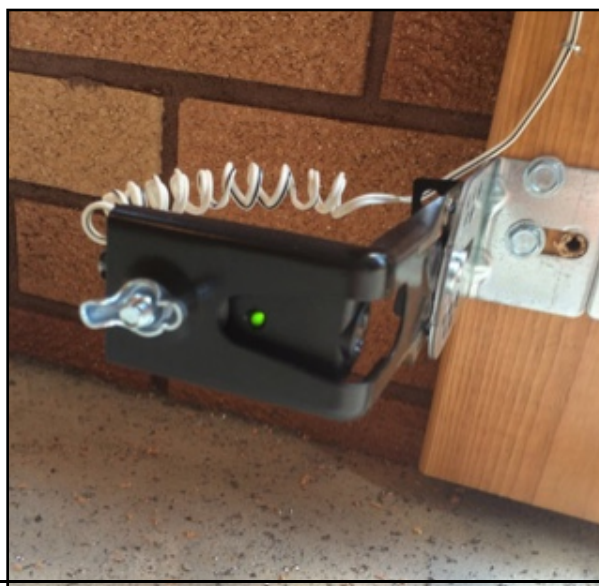
Figure 8-1

Auto-reverse was tested and was operational. Recommend lubricating the door rollers, hinges and rails with silicone for reduced operating noise and extended motor life.

The safety features of automatic garage door openers should be tested periodically to ensure proper and safe operation. Photo sensors are safety standards designed to protect small children from harm and should be installed about 6" from the floor. Check manufacturer for their recommendations. The safety reverse function should reverse when the door meets resistance. Occasionally the setting at the opener may need to be adjusted.

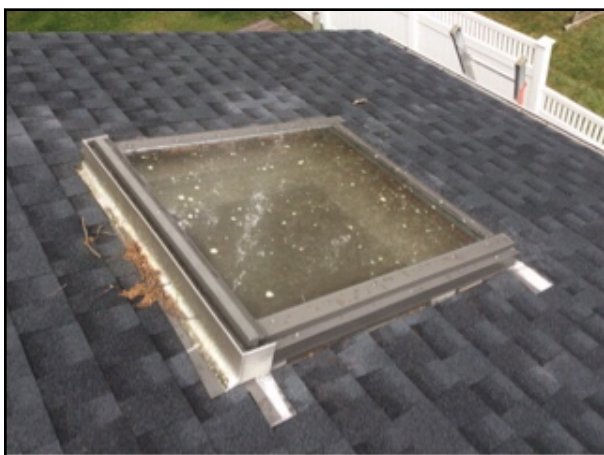
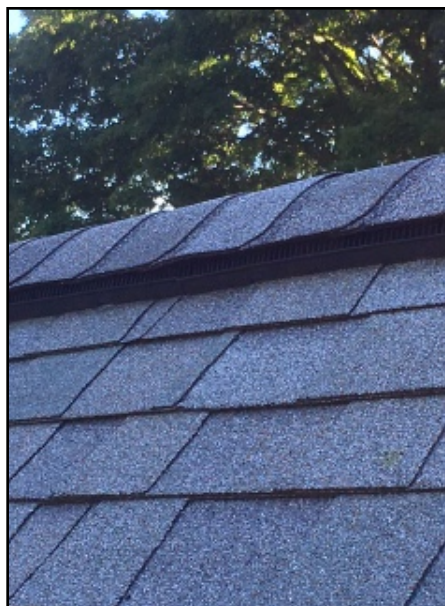
Figure 10-1

Where visible, the roof and roofing components appeared functional, showing normal wear and tear for it's estimated age and adequately protecting the roof at the time of inspection. The actual service life of the roof will vary depending on a number of interrelated factors including, but not limited to, weather, the quality of material and the method of installation. It should be your expectation to repair or replace any loose, missing or curling shingles from time to time.

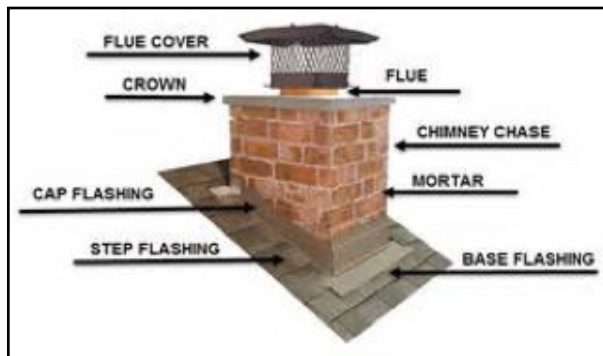
Figure 11-1

No cap installed- No chimney cap/flue cover was installed at the time of the inspection. A chimney cap should be provided to prevent damage to the chimney structure from moisture intrusion. The inspector recommends installation by a qualified contractor.

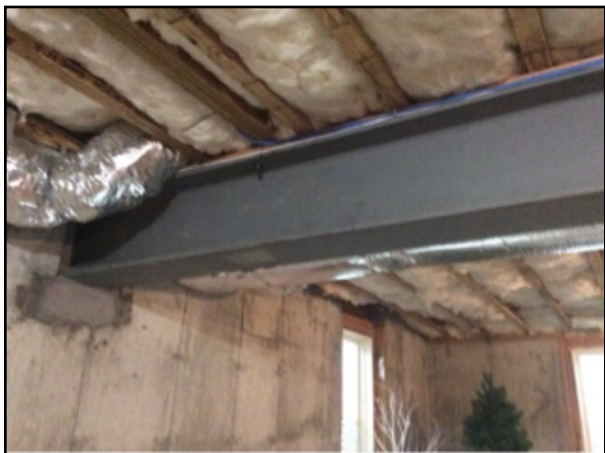
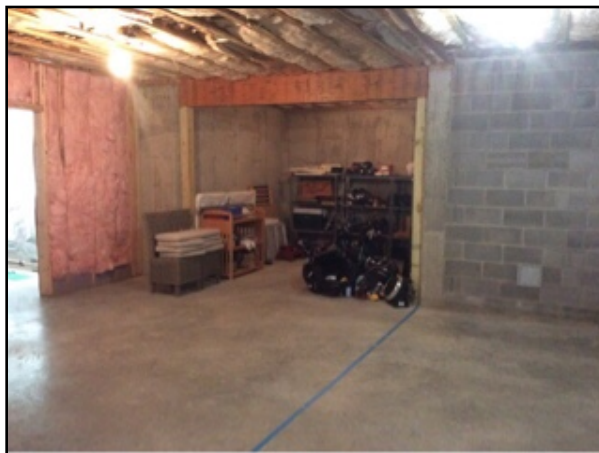
Figure 12-1

Structure OK at the time of the inspection, the Inspector observed no visible deficiencies in the condition of the home structure on the day of inspection. The General Home Inspection does not include evaluation of structural components hidden behind floor, wall, or ceiling coverings, but is visual and non-invasive only. Concealed items, including, but not limited to, electrical and plumbing components cannot be reported on, and are therefore excluded from this report. Notable exceptions, if observed, will be mentioned within.

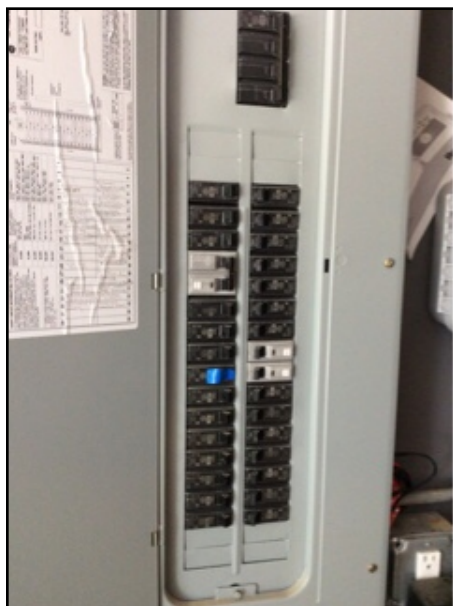
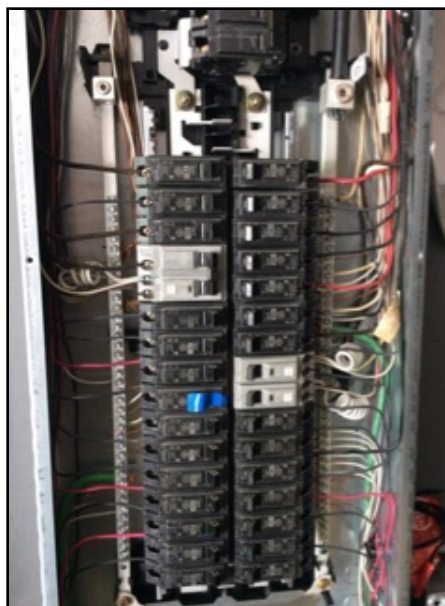
Figure 14-1

Interior views of main electrical panel. Be sure all breakers are labeled inside the panel for both safety and convenience. Familiarize all occupants of the home regarding breaker functionality.

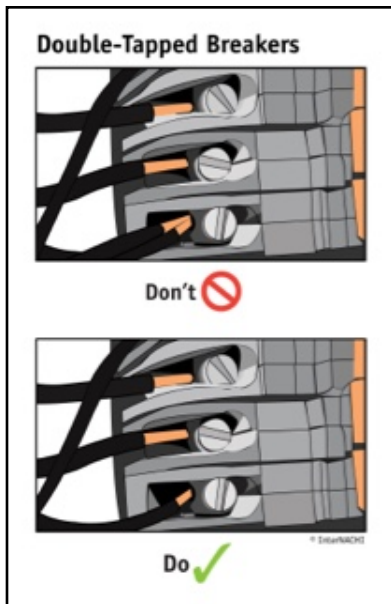
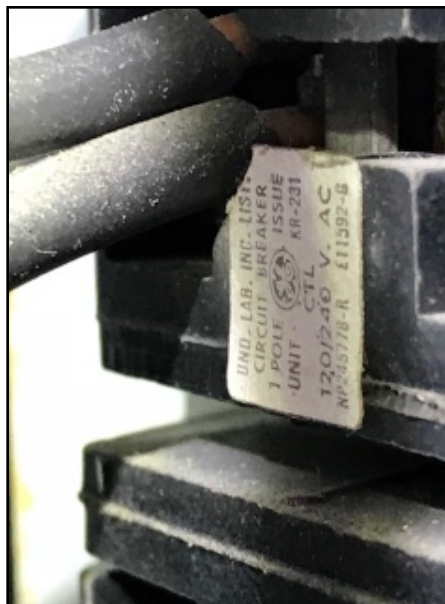
Figure 15-1

There are circuit breakers that have more than one electrical circuit tied into them. These circuits should be separated, so only one circuit is tied into a single breaker. Recommend repair by qualified electrician. Commonly referred to as a double tap. Safety hazard.

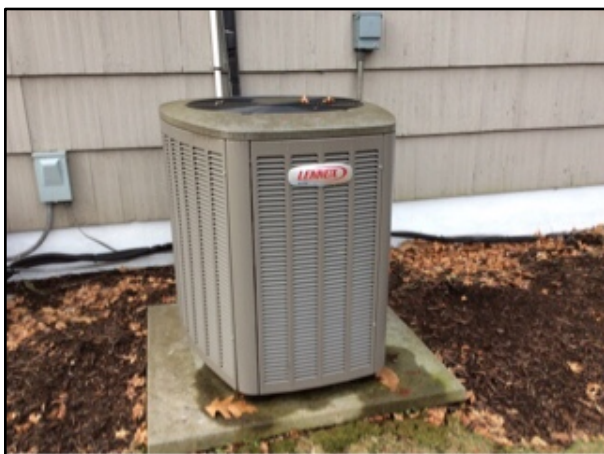
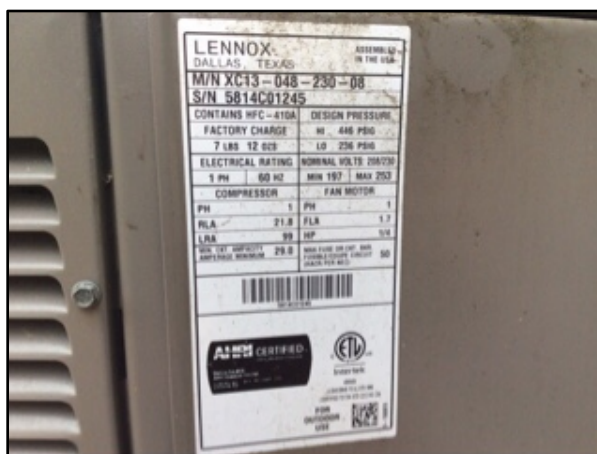
Figure 16-1

The heating and air conditioning systems were operational on the day of inspection. The systems were operated by normal controls and were in acceptable working condition on the day of inspection. To maintain peak operating efficiency, these systems should be professionally maintained/serviced on an annual basis. Change any applicable filters as required.

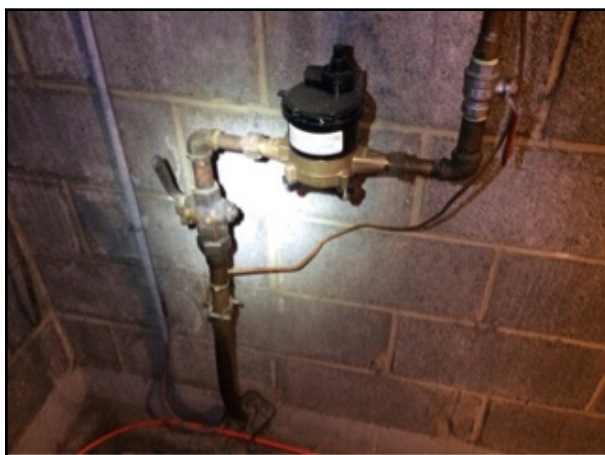
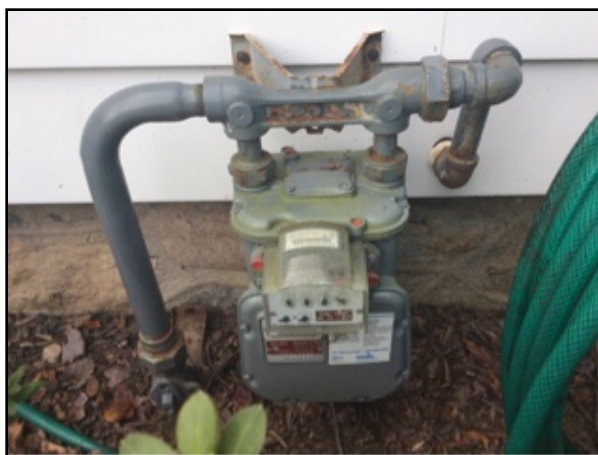
Figure 18-1

Views of water main/meter and gas main/meter for the home. Notable exceptions if observed are listed within. It is important that all of the homes occupants are aware of these locations in case of emergency.

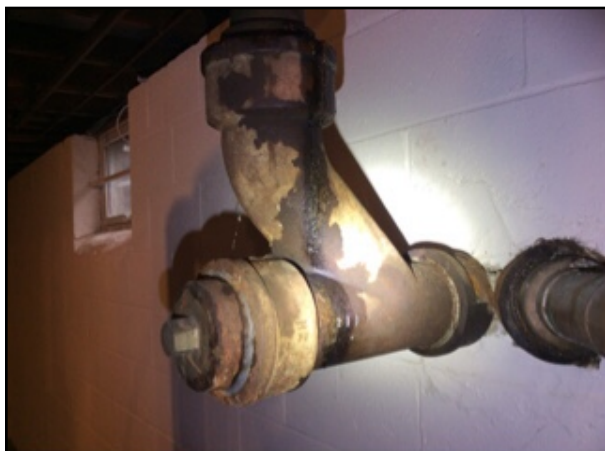
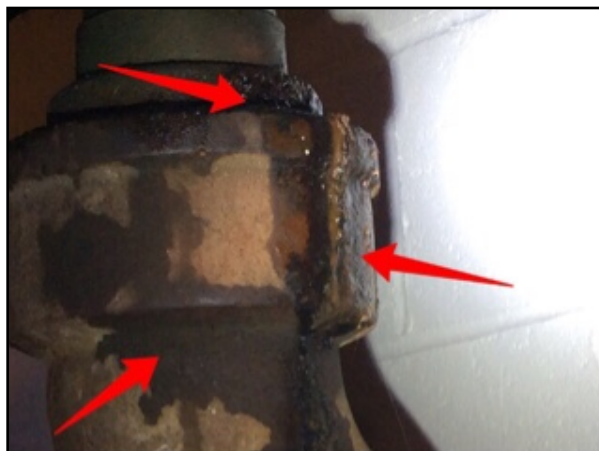
Figure 19-1

Visible seepage was observed at the cast iron waste line connections in the basement. Recommend qualified plumber evaluate the connections and repair as necessary.

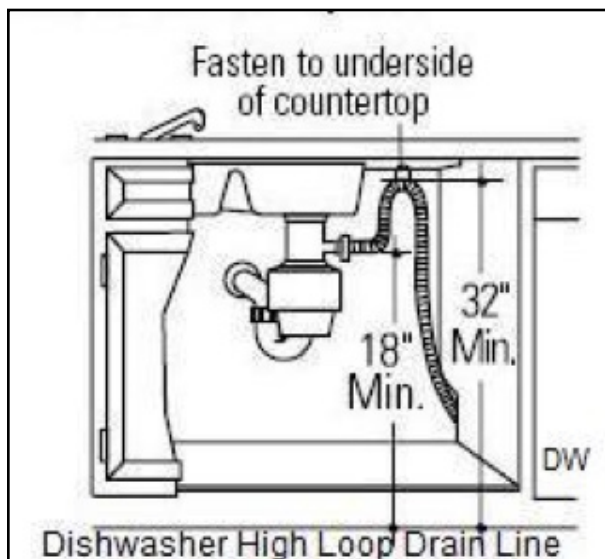
Figure 22.1

There was no high loop installed to prevent waste water from the sink drain or disposal from entering the dishwasher. You should have a proper high loop installed.

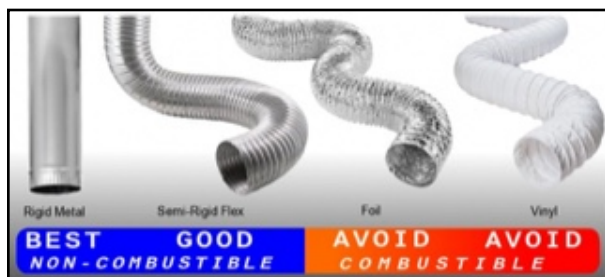
Figure 23-1

For enhanced protection against lint build-up and possible dryer fire, we recommend you clean the dryer discharge annually to prevent lint build-up. According to industry and municipal sources, thousands of fires a year start in laundry rooms resulting from failure to clean dryer vents or using the wrong type of vent.
